Multi-Purpose, High Temperature Repair and Rebuilding System

Belzona 1511 (Super HT-Metal) is a high temperature, paste-grade system for rebuilding equipment damaged by erosion-corrosion. This material can also be used as a high-strength structural adhesive or for the creation of irregular load bearing shims.

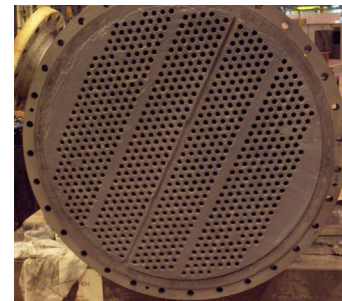
Heat exchanger tube face damaged by severe galvanic and pitting corrosion. Rebuilt with Belzona 1511 prior to the application of a Belzona high temperature coating.

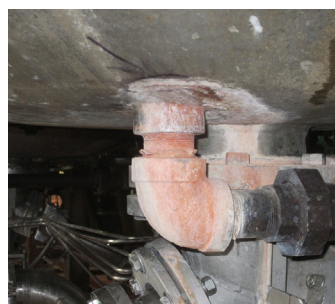
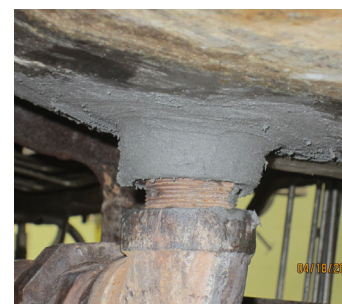
Process kettle developed holes in the weld seam as a result of corrosion. Belzona 1511 used to repair holes for the long term.

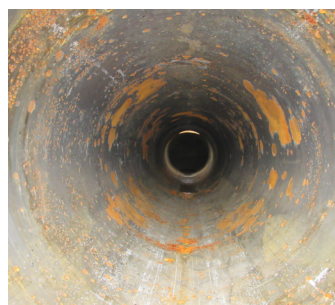
High temperature vessel suffering from severe corrosion. Pitted surface rebuilt using with Belzona 1511.
